# New Hampshire Volunteer Lake Assessment Program

## 2002 Interim Report for Pleasant Lake New London

NHDES  
Water Division  
Watershed Management Bureau  
6 Hazen Drive  
Concord, NH 03301

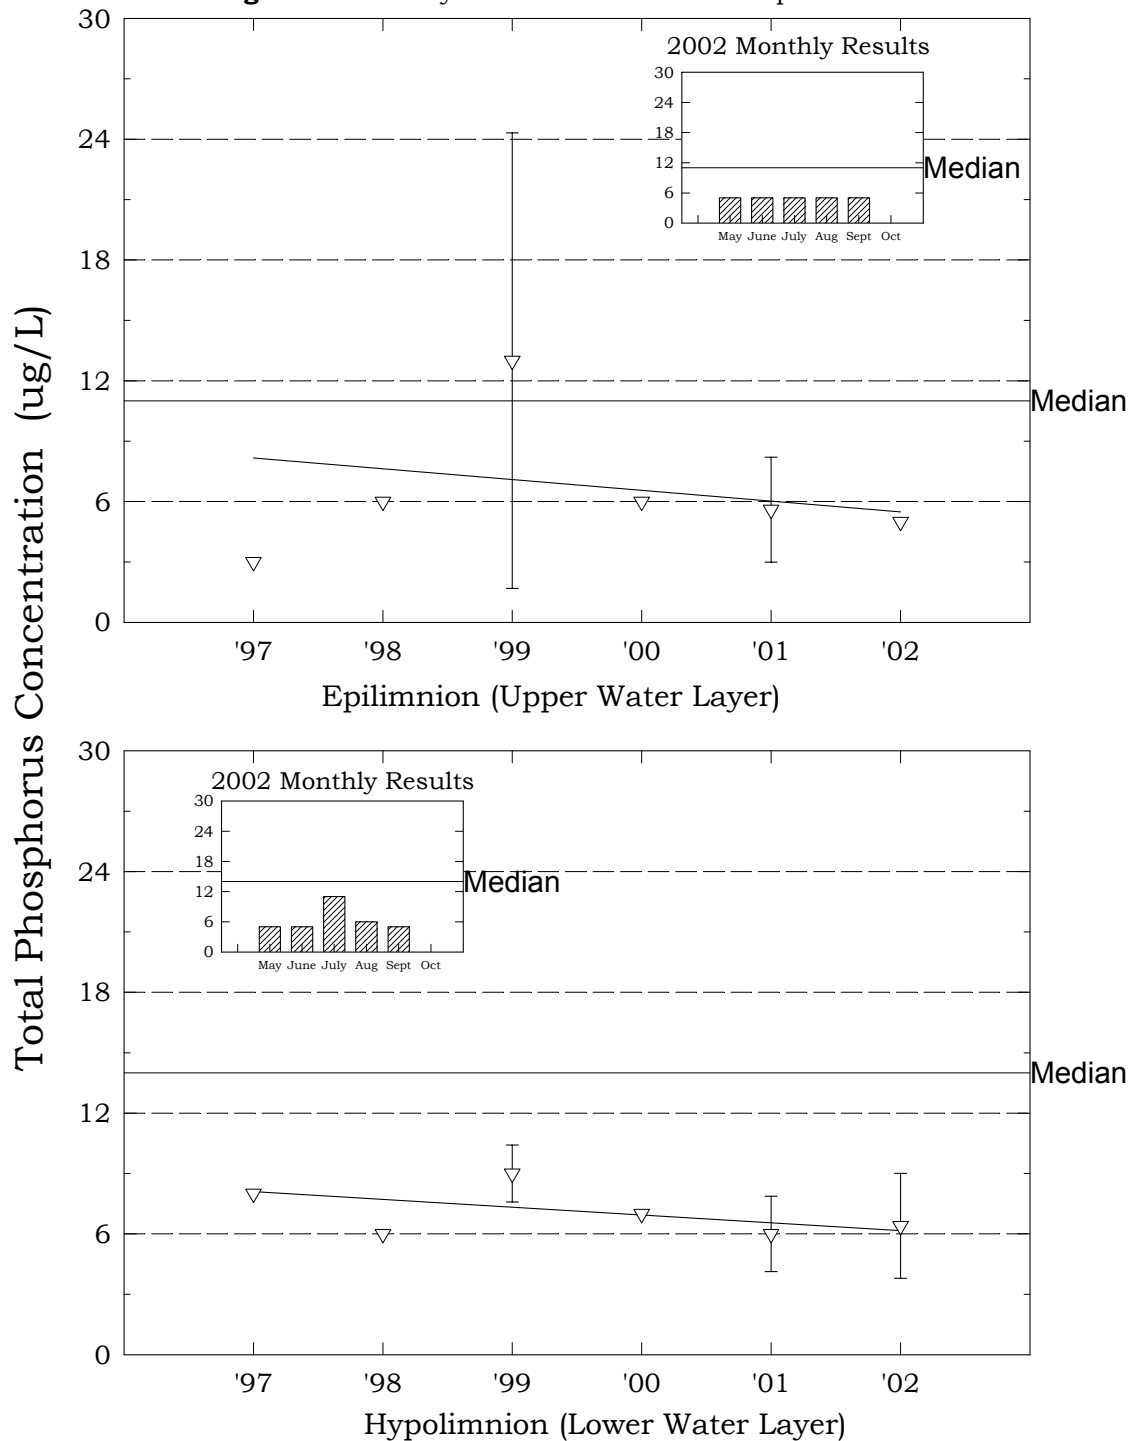
**Figure 3.** Monthly and Historical Total Phosphorus Data.

- **Figure 3 and Table 8:** The graphs in Figure 3 (Appendix A) show the amounts of phosphorus in the epilimnion (the upper layer) and the hypolimnion (the lower layer); the inset graphs show current year data. Table 8 (Appendix B) lists the annual maximum, minimum, and median concentration for each deep spot layer and each tributary since the lake has joined the program.

The historical data for the epilimnion (upper layer) and the hypolimnion (lower layer) show that the 2002 total phosphorus mean is **less than** the state median. Overall, visual inspection of the historical data trend line for the epilimnion and the hypolimnion shows **a variable** total phosphorus trend, which means that the concentration has **fluctuated** since monitoring began. Again, it is worthy to note that the annual mean phosphorus concentration in the epilimnion and hypolimnion has generally been **less than** the state median since monitoring began. We hope this continues!

One of the most important approaches to reducing phosphorus loading to a waterbody is to continually educate watershed residents about its sources and how excessive amounts can adversely impact the ecology and value of lakes and ponds. Phosphorus sources within a lake or pond's watershed typically include septic systems, animal waste, lawn fertilizer, road and construction erosion, and natural wetlands. If you would like to educate watershed residents about how they can help to reduce phosphorus loading into the lake, please contact the VLAP Coordinator.
